REMEDIAL INVESTIGATION WORK PLAN FOR PER- AND POLYFLUOROALKYL SUBSTANCES (PFAS)

FORMER FORT DEVENS ARMY INSTALLATION, DEVENS, MA

JUNE 2018

Prepared for:
U.S. Army Corps of Engineers
New England District
Concord, Massachusetts

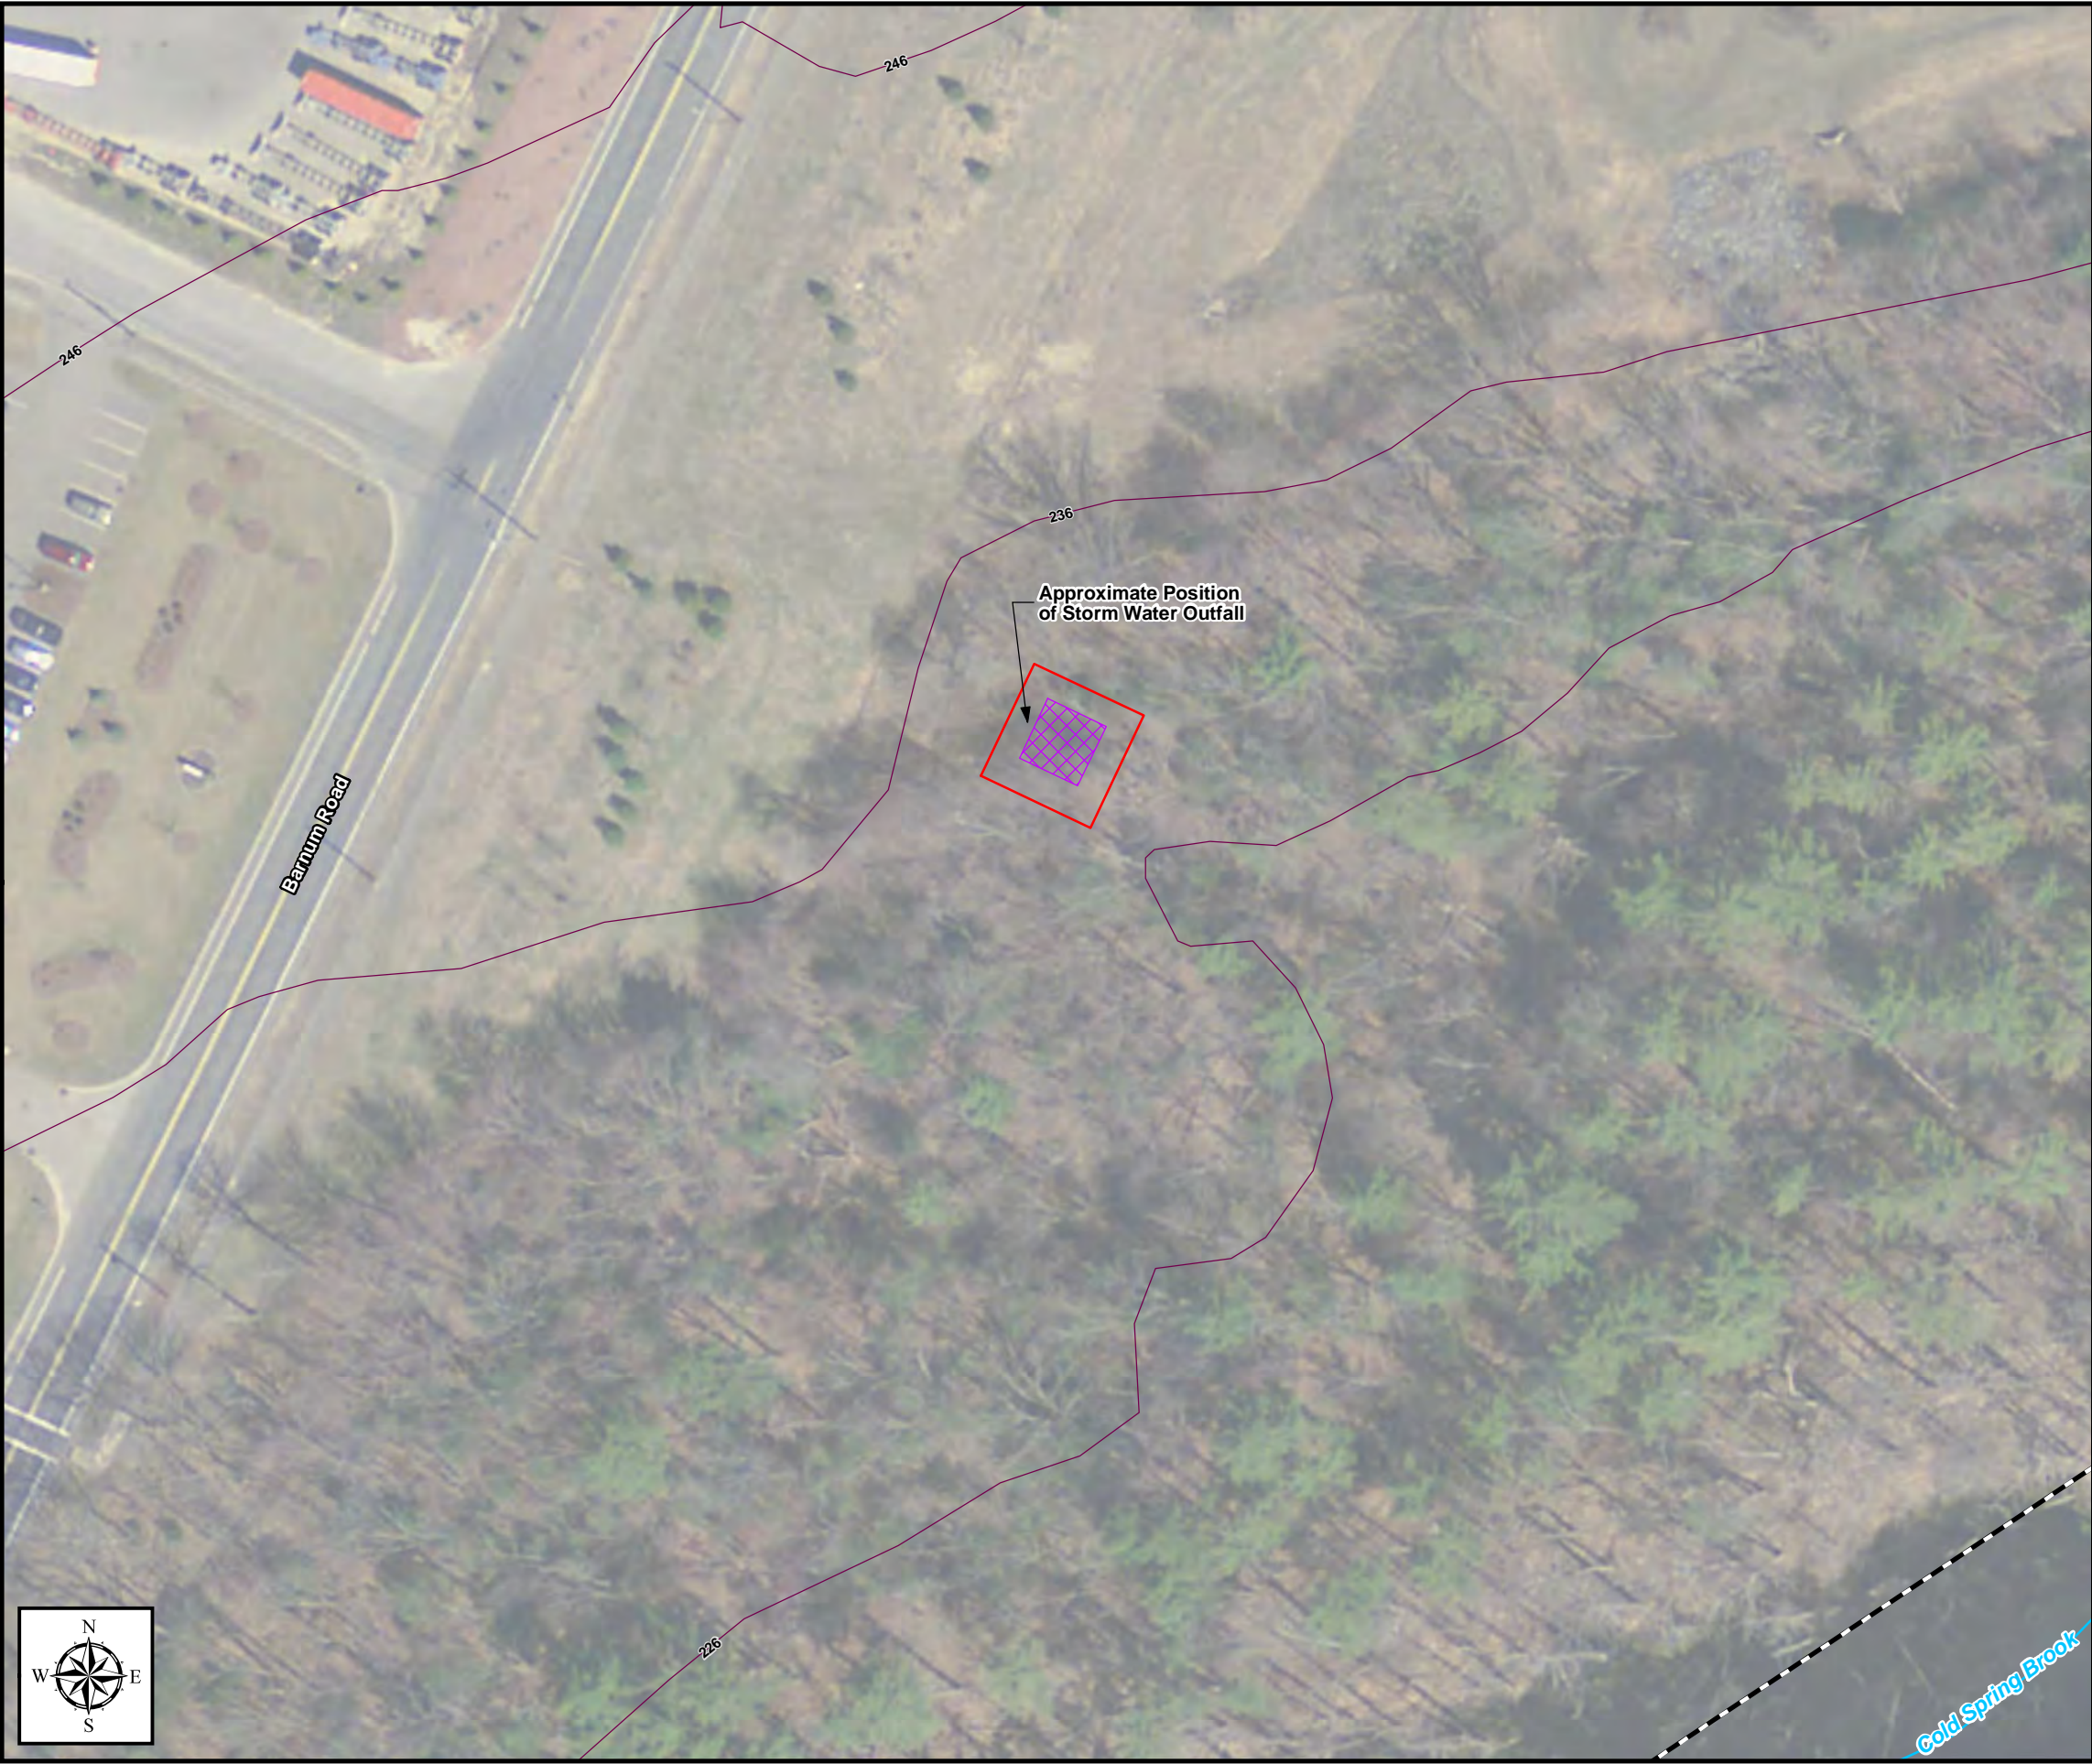
Figure
1-13

AOC 57 is located between Barnum Road and Cold Spring Brook (Figures 1-2 and 1-12). The portion of Devens that includes AOC 57 was used primarily as a storage and maintenance area for military vehicles. AOC 57 consists of three sub-areas (Area 1, Area 2, and Area 3) that are located south to southeast of Building 3713 and former Buildings 3756, 3757, and 3758 (Figure 1-13).

Former Building 3773 was used as an administrative building as part of the Army Reserve Center and former Building 3774 was used as storage (Figure 1-13). Firefighting equipment was stored at this location during the closure of the former MAAF (KGS, 2017c). Past firefighting training exercises with firefighting foam are believed to have been conducted behind former Building 3773 (BERS-Weston, 2018a).

AOC 75 is located off Saratoga Street (Figures 1-2 and 1-12). Building T-1445 (Figure 1-13) was reportedly used for storage of lumber and pipe (Arthur D Little, Inc., 1994). A large warehouse fire occurred at former Building T-1445 sometime during the late 1980s/early 1990s. Reportedly, due to the storage of flammable substances, the nature of the fire, and for purposes of firefighter safety, any available firefighting foam at that time was used to suppress the fire. Remnants from the fire were transported to and disposed of at AOC 5 and AOC 50 (BERS-Weston, 2018a).

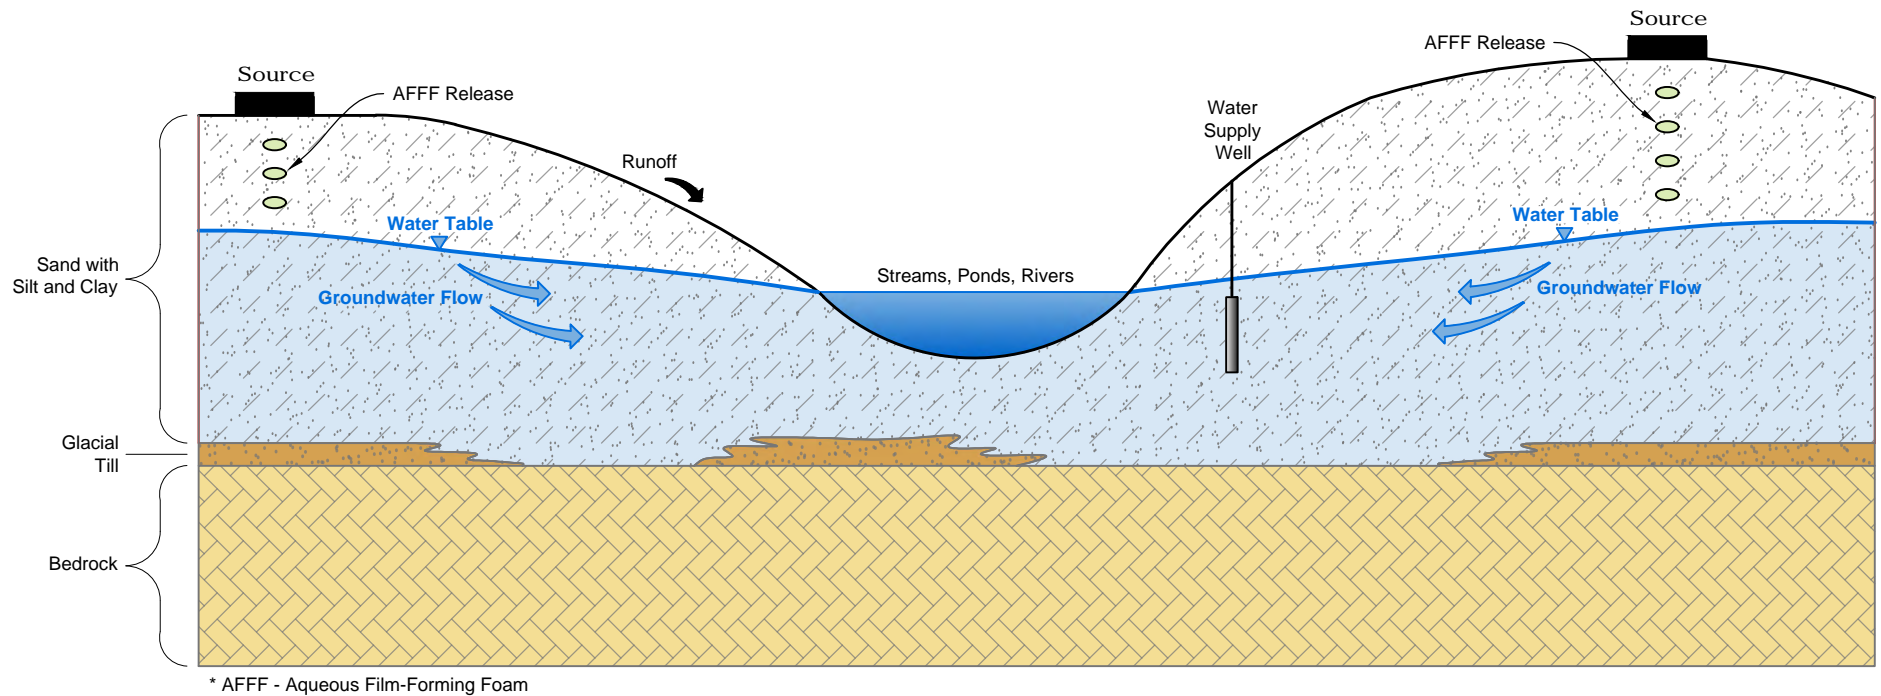
Devens PFAS Conceptual Model

Devans PFAS Conceptual Model
Devans PFAS Remedial Investigation Workplan
